Repair, Rehabilitation & Retrofitting of RCC Structures For Sustainable Development With Three Different Case Studies

CASE STUDY 1: G+3 BUILDING NEAR SEA SHORE AREA

CASE STUDY 2 : REPAIR OF REHABILITATION OF INDUSTRIAL STRUCTURE

CASE STUDY –III STRENGTHENING OF THE SUPPORTING SYSTEM OF A CYLINDRICAL LIQUID STORAGE TANK

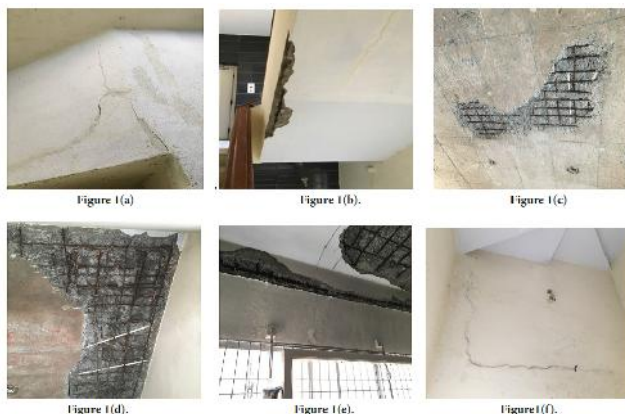
In this paper we have discussed the repair and rehabilitation work carried out in a G+3 residential building located very close to sea shore (Near Besant Nagar Beach, Chennai). The building is severely damaged due to salt water and chloride attack, suffer with corrosion of reinforcement, spalling of concrete in floor and roof slabs, major cracks at staircase landing and cracks in RCC and Masonry structures. A detailed visual observation was made on all the columns, beams and slabs of the above said location and the following observations were made, excessive spalling was noticed in few of the columns and beams in the ground floor

(Figure 1a), Excessive spalling was noticed in all the stair case landing slab portion (Figure 1b), in many places the slab portions has dampness (Figure 1c), and corrosion traces (Figure 1d), cracks were noticed at the concrete and brick work joints (Figure 1e), major cracks seen in masonry wall (Figure 1f).

Repair strategy involved, removal of delaminated concrete cover, anti corrosive coating, polymer modified mortar, injection of epoxy grout for the repair of beam column junction and masonry crack, self-sacrificial anode to prevent corrosion of reinforcement, micro concrete for slab and column, additional reinforcement with anti corrosive coating, glass fibre wrapping for column to increase ductility, and polymer modified mortar for repair of RCC and Masonry crack.

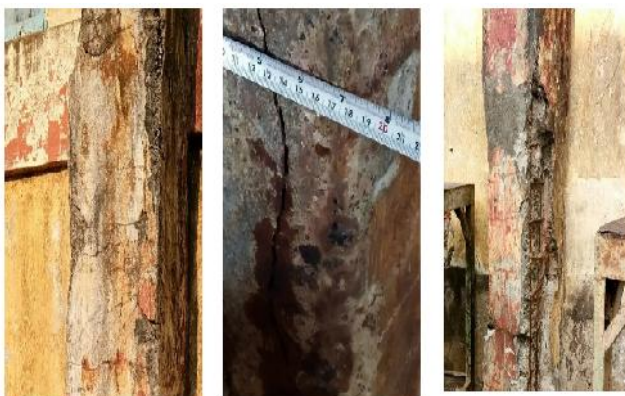
Hairline cracks: The hairline cracks are observed in highest number on the structure. Mainly we can observe hairline cracks on the horizontal members and these hairline cracks are formed mainly due to temperature stress. The hairline cracks are also called as lighter cracks which are not so hazardous and can repaired easily.

Wider cracks: The wider cracks are observed mainly on the vertical members(columns) which are caused by stress

developed inside the column due to corrosion. These cracks are also even responsible for higher structural damage.

Corrosion: The corrosion of reinforcement is in high range on the exposed face of the structure which is directly responsible for formation of internal stresses inside the reinforced concrete members. The roof truss is also corroded completely and may fall any time

Hairline Cracks on column

Wider cracks on Column

Corrosion of Rebar

- Based on the results obtained from the study the following conclusions made are as follows,
- It is noticed that, the roof of the existing structure was highly hazardous and the replacement is mandatory.
- The existing masonries are highly damaged and are significant for instant repair.
- The vertical members(column) lost their strength due to high range of cracks, spalling of concrete and internal cavity.
- The bottom portion of vertical members are impaired majorly as compared to other portions.
- The central columns are highly impaired and faced for quick retrofitting.
- The corrosion rate in existing RC members along with roof truss found to be extremely high.

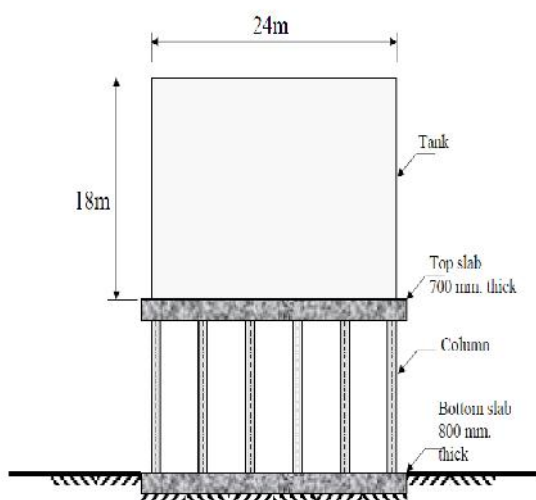
- Steel cylindrical tanks of 24 meters diameter and 18-meter height rest on an elevated support .
- The supports consist of two reinforced concrete slabs connected by columns.
- Following the hydro testing of the tanks, numerous cracks were observed in the top slab and columns supporting the elevated tank foundations. Significant differential settlement in the tank foundation base slabs was also observed.
- The foundation for each tank is constructed in reinforced concrete and takes the form of two flat slabs of octagonal shape in plan separated by a total of 25 columns of approximately 3.91 m height.
- The upper slab is 700 mm thick whilst the lower slab is of 800 mm thickness

- With the exception of the four central columns, flexural cracking was observed within each existing reinforced concrete column.
- Cracking has been observed at the soffit of the upper slab.
- The width of these latter cracks has been estimated to be in the range of 0.3–1.0 mm.
- These cracks join together to form a grid pattern around the central four columns. A level survey of the base slab has been carried out.
- This revealed that the structure underwent significant differential settlement when loaded.
- Furthermore, much of this settlement remained as a permanent set when the load was removed.

- The finite element modelling of the supporting structure has carried out by the original consultant using ANSYS (Version 5.6)
- From the results of the finite element analysis of the tank foundation, it can be seen that the bending moment of resistance of the top and bottom slabs were exceeded in localized areas
- Out of all the options considered: (thickening the columns, or slabs), adding shear walls and using carbon fiber reinforced polymer CFRP for slab strengthening, the solution comprising of shear walls indicated a suitable method for enhancing the capacity of the structure
