Effect of Ferrocement Jacketing on The Compressive Behaviour of Columns With Corroded Reinforcements

Abstract-Corrosion of reinforcements is found to be one of the predominant reasons behind the limited service life of Reinforced Cement Concrete (RCC) structures, resulting in reduced load carrying capacity. Therefore, strengthening of deficient structural elements is necessary to increase the load carrying capacity and stiffness. Ferrocement jacketing is one of the efficient and cost effective techniques for strengthening deteriorated and weak columns. The present study deals with the behaviour of columns having corroded reinforcements of varying levels of corrosion such as 5%, 10% and 15% mass loss in reinforcements and the effect of ferrocement jacketing on its load bearing capacity. Total of 63 column specimens will be casted which will consist of 9 control specimen. The control specimen will be of non-corroded reinforcements in group of 3 each for concrete grade of M-20, M-25 and M-30. 27 columns will be casted with 9 columns in each grade of concrete. From 9 columns group of 3 columns for 5%, 10% and 15% corrosion reinforcement for same grade will be casted. Similar 9 columns

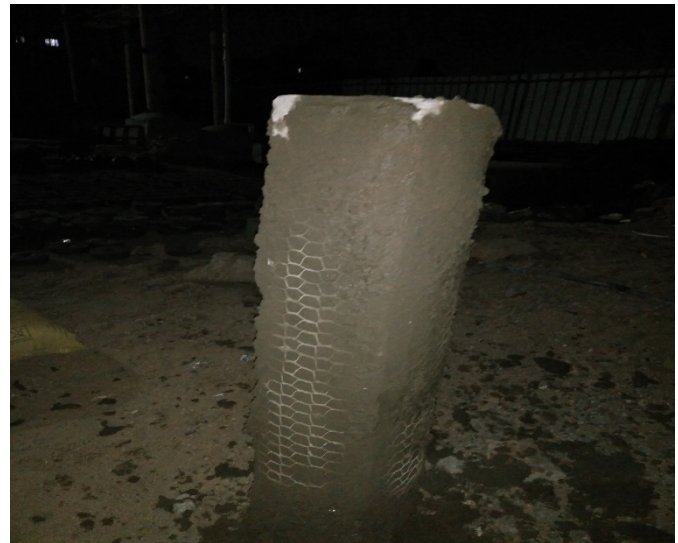
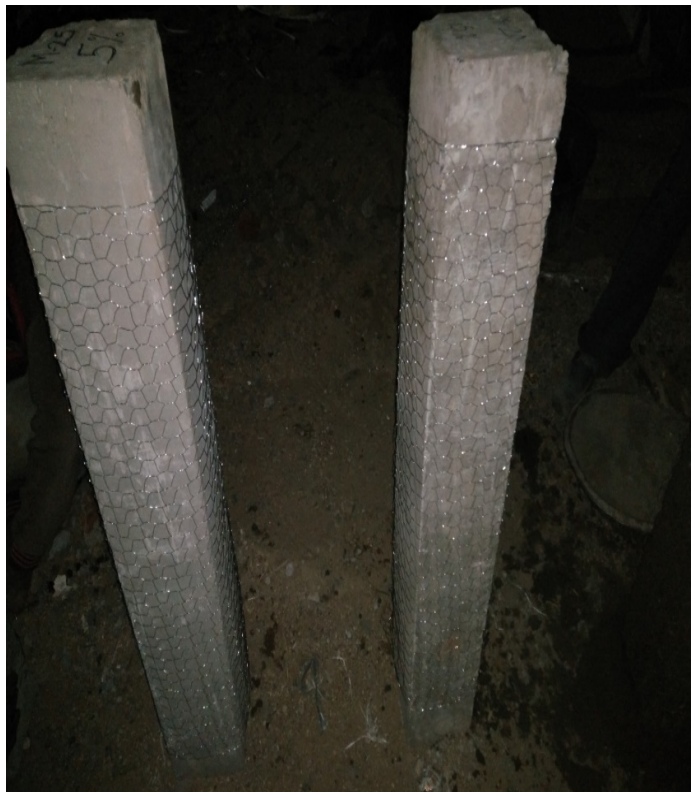
The failure load of all the non jacketed columns were tested and then the columns were jacaketed with ferrocement with 1:2 ratio of cement and sand and wire mesh. After curing the jacaketed columns for 4 days and then the failure load of the jacakted columns were tested accordingly.

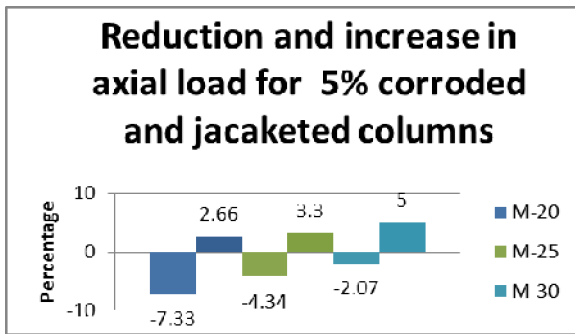
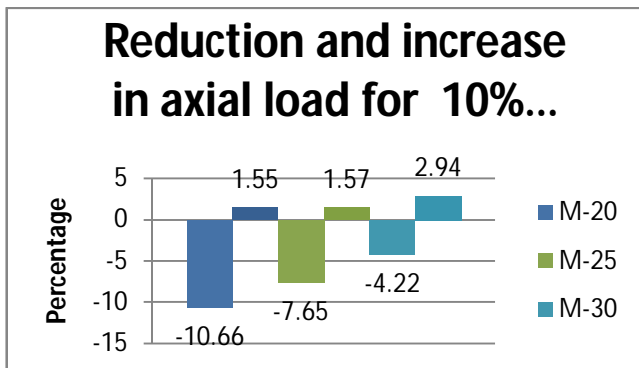
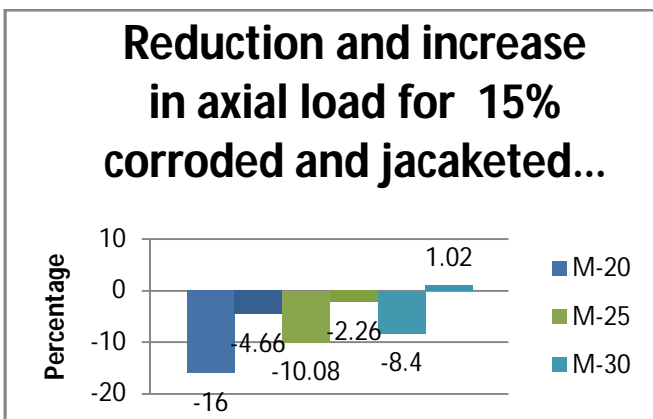
The conclusion that has been obtained from above results is that corrosion on the higher grade of concrete is affected less than that of the lower grade of concrete. Also after ferrocement jacaketing on the columns the effect of it is more on 5% corroded specimens than on 15% corrosion because the failure load increases more than that of normal specimen had obtained.

COLUMNS	M-20	M-25	M-30
Normal Specimen	450	575	678
5% corroded reinforcements	417	550	661
10% corroded Reinforcements	402	531	647
15% corroded reinforcements	378	517	621
5% corroded reinforcements jacketed with ferrocement	462	594	742
10% corroded reinforcements jacketed with ferrocement	457	584	726
15% corroded reinforcements jacketed with ferrocement	429	562	698
