To Study the Effect of Piston Scratching Fault on Vibration Behaviour of An Ic Engine

^{1,2,3,4,5} HOPE Foundation's Finolex Academy of Management and Technology, Ratnagiri-415639, Maharashtra, India

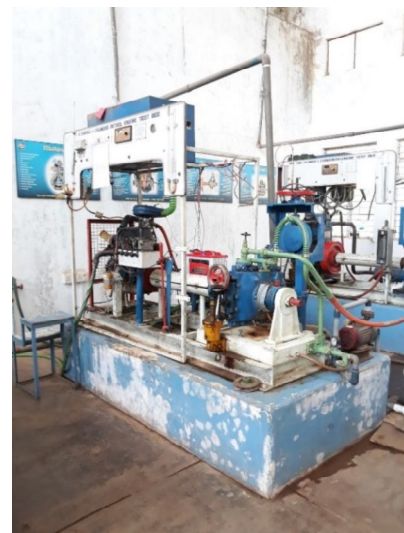
Fig. 1 Four-stroke four-cylinder petrol engine.

The experiments were performed on inline four-stroke four-cylinder petrol engine. The engine specifications are given in table 1. All the readings were taken at 1500rpm and by applying different loading conditions. For loading the engine water brake dynamometer was used.

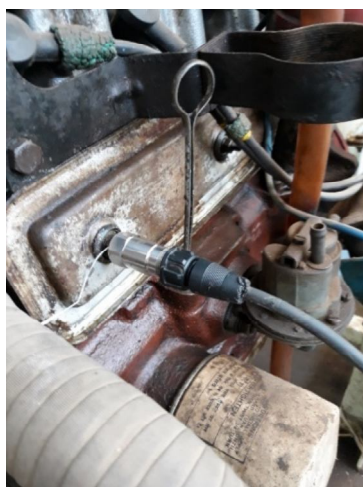
Fig. 3 Location of an accelerometer

To measure the vibrations piezoelectric accelerometer was installed on M6 fine threaded bolt present at cylinder block. The position for mounting of accelerometer is shown in fig.3

The chosen measurement technique was based on vibration signature analysis. The sensor was attached to the engine on M6 bolt available on the cylinder head. The experiments that were done showed that there is a more vibration at the starting of engine and that may the vibrations in whole body of the vehicle and that may cause to discomfort of the passengers

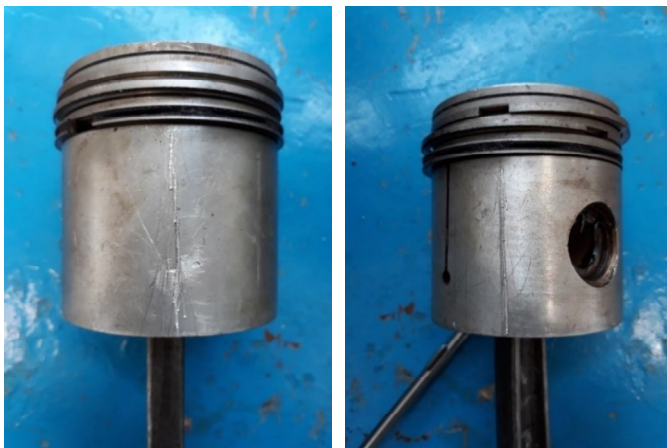
Fig.6 Scratched (Faulty) piston

After disassembling the engine and checking the health of its components especially piston groups and cylinders, third piston was scratched by using nail. The depth value of was adopted from the statistical population of the faulty pistons with similar failure which had naturally been occurred during the real engine operations. Scratching is among the preliminary stages of sliding surface damage. Therefore, if a procedure could effectively detect this stage of surface damage, it will be possible to prevent the progression of surface damage. So, the development of such diagnostic procedure is worthy indeed from this point of view. Based on

1. This scratch increases the roughness of the piston skirt surface in micro-scale.
2. As the oil film thickness in the central region of the skirt so called load bearing region, is less than that in around the skirt, this scratch is located at the central area of the skirt. In other hand, this scratch could be a channel for the escape of the lubricant from the area between the piston and cylinder. In this condition, due to the boundary lubrication the friction in this area will increase, and the contact between the piston skirt surface and cylinder will be probable, and consequently abrasive wear will occur.

After the above process, the engine was assembled with the faulty piston and prepared for the experiment. Afterward, the engine was tested according to the test plan, and all engine parameters and vibration data were captured during the experiment. From now, the term of “Healthy” represents the first experiment, whereas the term of “Faulty” denotes the second experiment in which the piston and cylinder#3 were experienced abrasive wear

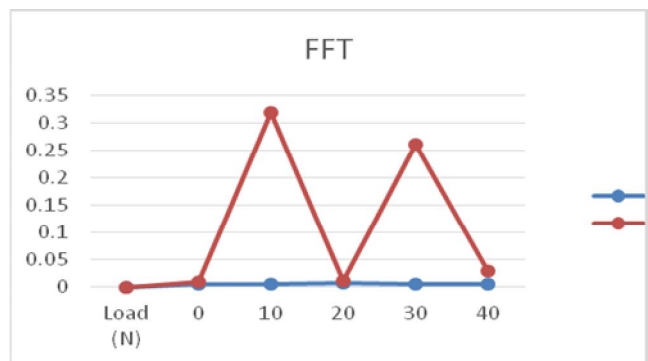
Fig. 7 Load vs FFT

Charts below shows the variation of different parameters of engine vibrations with respect to the load applied. It can be easily observed that the values related to engine running with faulty piston are greater than that of the engine running with healthy piston, indicating the increase in the vibrations of an IC engine when the piston is subjected to abrasive wear.

1. Peak values are increased.
2. Kurtosis values are increased.
3. FFT values are increased.
4. RMS values are increased.
