Investigation of Existing Structure For Strengthening Purpose

II. STRUCTURAL AUDIT OF EXISTING BUILDING THROUGH VISUAL OBSERVATION AND CHECK OF COMPRESSIVE STRENGTH BY NDT

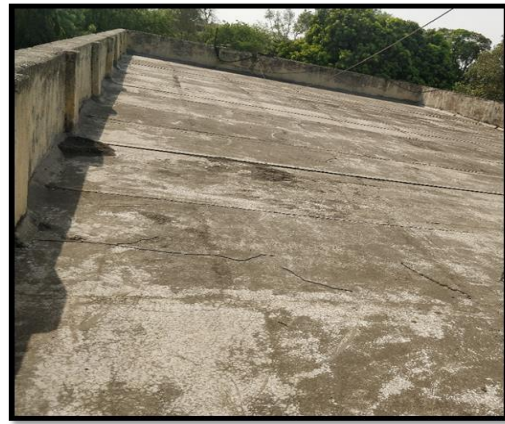
Fig 1 Terrace floor

1. Strength of inverted beam is varying in different places abruptly.
2. Terrace slab are weak in tension, showing NDT reading extremely low.
3. Cracks are formed on walls of toilet units of terrace.
4. Opening of reinforcement at bottom of slab, rusting of all reinforcement it weakened Structural members in tension.
5. Structural cracks observed on walls and beams of staircase units.
6. All waist slabs are seen damaged, concreting material are spalling & deterioration at various places.
7. Strength of riser & tread are reduced due to waist slab thickness damaged.
8. R.C.C pardi of stair case unit showing average strength.
9. Columns are showing varying strength up to parapet level minor cracks are formed so strength are less as per test records.

1. Strength of inverted beam is varying in different places abruptly.
2. Terrace slab are weak in tension, showing NDT reading extremely low.
3. Opening of reinforcement at bottom of slab, rusting of all reinforcement it weakened Structural members in tension.
4. Structural cracks observed on walls and beams of staircase units.
5. Columns are showing varying strength up to parapet level minor cracks are formed so strength are less as per test records.

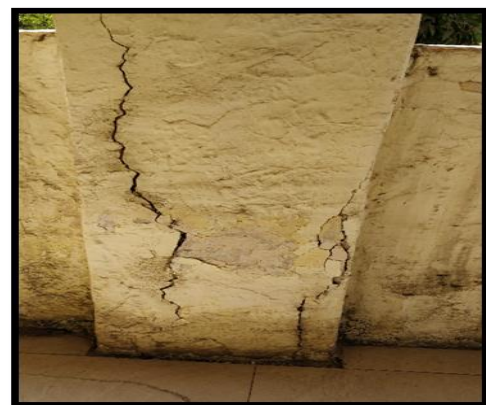
Fig 2 Terrace floor

1. All RCC Chajjas are weak & partly opening of reinforcement & spalling of RCC material, as result strength observed is zero. Strength of columns are weak in compression, at various places.
2. Major structural cracks are formed opening, of columns front & both two sides, rusting of reinforcement showing strength are zero.
3. Strength of slab beams are showing average.
4. In walls minors cracks are formed it seen outer side of projection, spalling of plasters are many places.
5. Observed junction joints of beam and columns are corrugated at various positions so strength are less measurable.

1. All RCC Chajjas are weak & partly opening of reinforcement & spalling of RCC material, as result strength observed is low.
2. Strength of columns are weak in compression, at various places.
3. Major structural cracks are formed opening, of columns front & both two sides, rusting of reinforcement showing low strength.
4. Strength of slab beams are showing average.
5. In walls minors cracks are formed it seen outer side of projection, spalling of plasters are many places.
