Study on Rehabilitation of RCC Building With Case Study

1. Structural Audit Report:-

Table -1: Case Study- Basic Information of RCC Building.

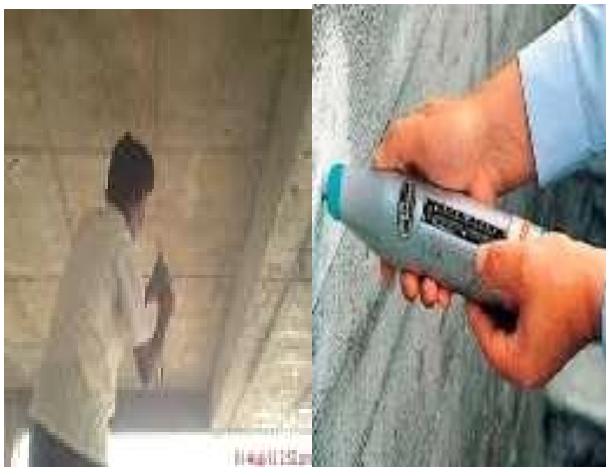
Fig 7 : Non-Destructive Test [NDT] on Column and Slab in Building

(Rebound Hammer Test)

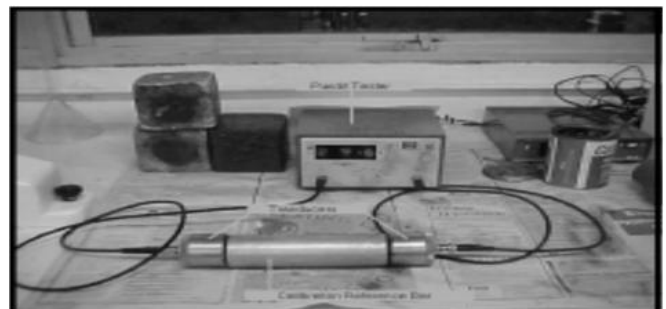
Fig.Ultrasonic Pulse Velocity Testing Machine

Ultrasonic Pulse Velocity Test-[IS13311 Part-1]

This test involves measuring the velocity of sound through concrete for strength determination. Since, concrete is a multi-phase material, speed of sound in concrete depends on the relative concentration of its constituent materials, degree of compacting, moisture content, and the amount of discontinuities present. This technique is applied for measurements of composition (e.g. monitor the mixing materials during construction, to estimate the depth of damage caused by fire), strength estimation, homogeneity, elastic modulus and age, & to check presence of defects, crack depth and thickness measurement.
