Forensic Investigation of Concrete Structures

Name of building- Namratana

Type of Structure - RCC Building of G+5 floors

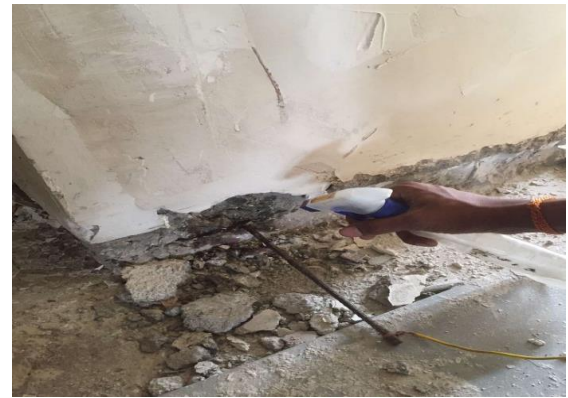
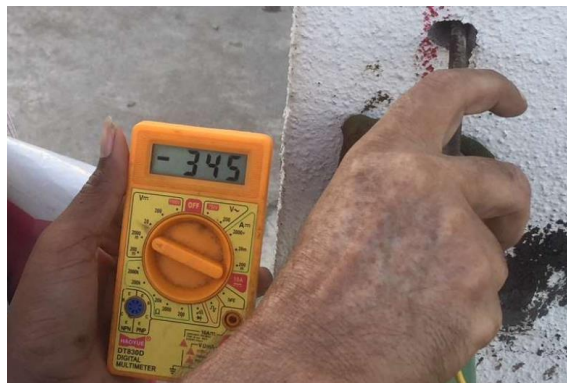
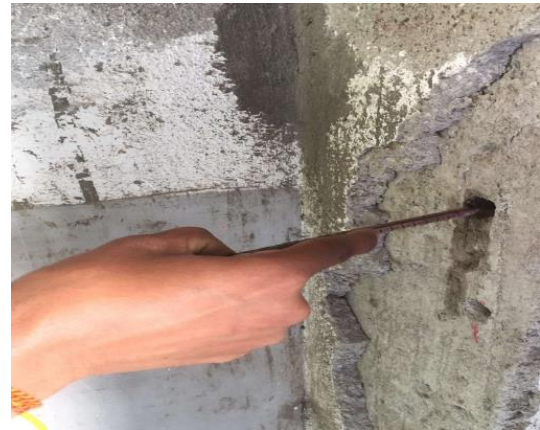
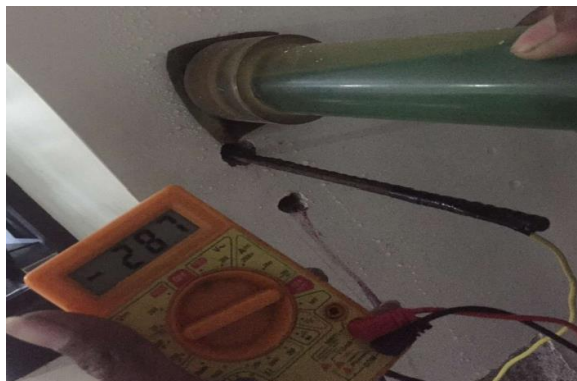
Half Cell Potentiometer Test Criteria as per IS 516 (PART 5 / SEC 2) : 2021		HCP Results Interpretation
Half Cell Potential Reading (Cu/CuSO4)	Probability of active corrosion	No. of readings
-200mV or less negative than -200mV	Low (10%)	1
-200mV to -350mV	Uncertain (50%)	7
< -350mV or more negative than -350mV	High (90%)	0
< -500mV	Severe corrosion	0
