Study of Non Destructive Test on Concrete

Abstract- In the recent past, Non Destructive Techniques to evaluate defects and strength of concrete have developed great importance. These techniques have their own advantages as well as limitations, when compared to conventional strength estimation and damage detection tests. In this project various concrete specimens (Beams and Square Slab) were cast and discontinuities were created in these using thick paper sheet and wooden pieces at varying depths and position within the specimens. The objective of this project was to detect these defects by using three techniques: (1) Rebound Hammer Test (2) Ultra Sonic Pulse Velocity Test (3) Thermal Imaging Technique And finding the most suitable and economical technique to serve the purpose. Use of Thermal Imaging Technique in this area is a very new concept and its relevance in this area has been explored in this project and it has been found that this technique is of great use in detecting defects in concrete. Please note that this project does not deal with determining the strength of specimens.

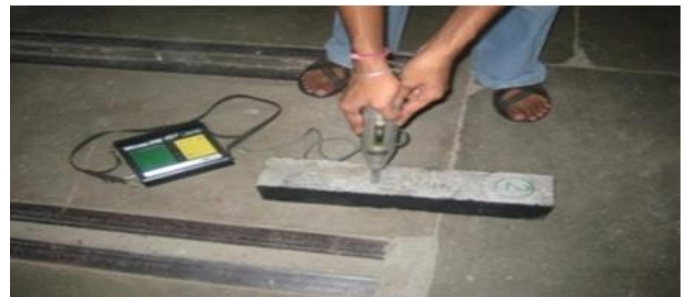
FIG 2.1 Rebound Hammer (Schmidt Hammer)

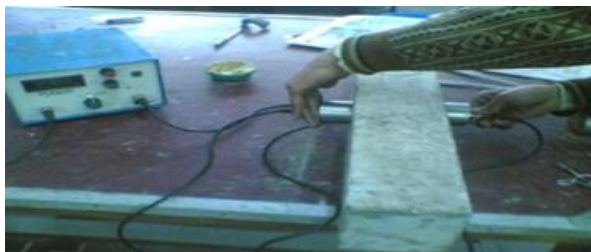
FIG 3.2 USPV Test Apparatus (PUNDIT)

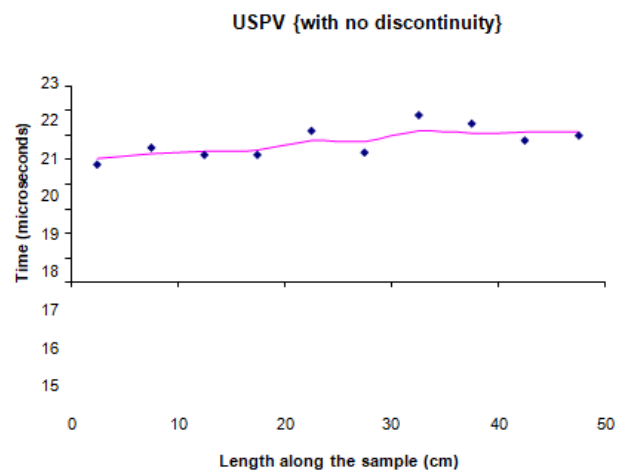
FIG USPV test result on beam with no discontinuity

As expected the Time taken by pulse to travel from one face of beam to other (10cm) do not vary much along the length of the beam(50cm).

From my experiments it can be seen that the USPV Test is the one on which we can completely rely to serve our purpose. From Time taken by pulse vs Points along the length of specimen] we can easily see that at the points of discontinuities the time taken by the pulse to travel across the beam increases considerably and this point is seen as a peak in the graph.
