Damage Characterization and Defect Study on Natural Fiber Reinforced Polymer Composite Using Infrared Thermography

Abstract- In a various engineering fields, composite materials are been replacing the conventional materials. During manufacturing of composites, imperfections appear on the composites due to various moulding parameters such as temperature, pressure and humidity. Imperfections observed on the composites include porosities and resin shrinkage during recurring. The presence of voids or cracks or inclusion in the composites can cause a sudden failure in the composites. There are several methods to characterize such defects. The main purpose of the present study is to investigate the imperfection on natural fiber reinforced polymer composites by using a non destructive testing method. This method is suitable to identify the random voids and its morphology and also the cracks in the natural fiber reinforced polymer composites non-destructively. IR thermography is a surface temperature measurement technique that is used to detect spatial variations observed in the surface of the composites. It reveals flaws by searching anomalous hot-spots after thermal excitation. In therm

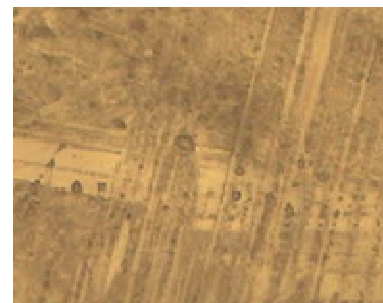
Figure 5. Misalignment of fibres

The misalignment of fibres in the natural fibre reinforced polymer composites occurs as a result of the weak interfacial adhesion between the fibre and resin and can also be occurred due to the poor dispersion of the fibre and matrix. Khalina et al.[16] studied about the mechanical properties of the injection moulded oil palm fibre reinforced composites and they reported that the fibre roughing will promote the mechanical properties such as interfacial bonding between the fibre and the resin. Figure 5 shows the misalignment of fibres specimen of 60:40 Banana/epoxy with thickness of 0.5 cm.
