# Condition Assessment And NDT Of Building

Building name : Vasant Mahal Building Santra Market Marwadi Cut Piece Chal Nagpur-440018

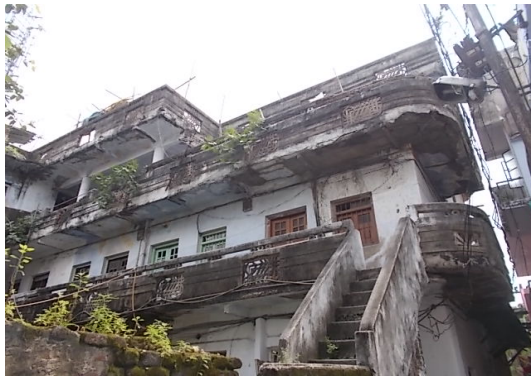
The building has 70 years long span which shows the various damages including seepages, spalling, reinforcement exposed, major and hair cracks.

1. The building around 70 years old
2. Reinforcement exposed and damaged
3. Concrete portion was fully vanished and only because of it, areas was totally restricted
4. Minor cracks or hair cracks noticed
5. Wall plaster was damaged
6. Spalling observed
7. Vegetation observed in balcony area
8. Balcony and chhajja portion was fully reinforcement exposed from bottom side

1. All the cover concrete (up to a minimum thickness of 50mm) shall be chipped off exposing the sound concrete.
2. Surface shall be cleaned by sand blasting or water jetting
3. Wherever core concrete has voids and honeycombs, it should be strengthened by means of grouting with cement
4. All the reinforcement shall be cleaned thoroughly
5. An anticorrosive coating shall be applied on the surface of the reinforcements
6. Micro concrete shall be placed in stages of 1.5m. For better bonding between old and new concrete, shear connectors shall be provided
7. After demoulding and curing, the entire exposed surface of the structure shall be coated with a concrete surface coating which will resist the ingress of carbon dioxide and chloride from the atmosphere.

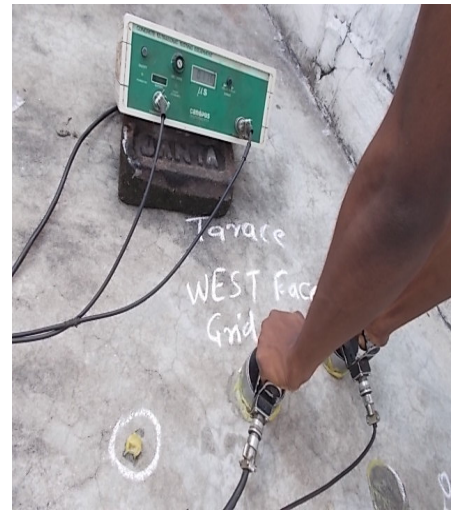
Ultrasonic Pulse Velocity test is conducted on critical column and beam locations in the building. The test is conducted as per the procedure mentioned in IS 13311: Part I. Before measuring the pulse velocity using the transducers, a thin layer of grease is applied to testing members so as to act as acoustic coupling between the transducers and the concrete surface.

From this test it is observed that the ultrasonic pulse velocity results with direct, indirect and semi direct method includes that readings are below 3.5 Km/sec, at maximum location. (Refer to IS 13311 ( Part I )1992). "Non destructive testing of concrete is medium and doubtful at maximum location. The readings are taken with indirect method as per IS 13311 (Part I) indirect reading gives less pulse velocity than direct method generally by 1Km/sec.

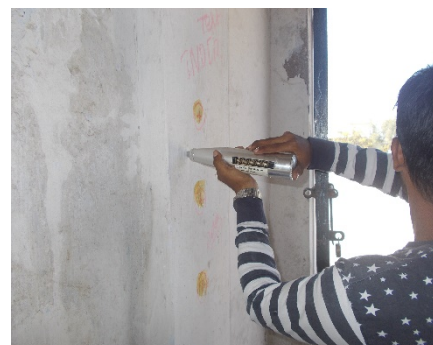
Rebound Hammer test is conducted on the column faces using an N type Schmidt hammer test for concrete. The test covered critical column and beam locations in the building. The test is conducted as per the procedure mentioned in IS 13311: Part II. For each column, six readings are taken ensuring a minimum distance of 20mm between two successive points. Finally, average of these readings is taken as the representative rebound number for the concrete of that column. Average rebound number which is obtained is to be corrected by considering the carbonation effect. The interpretation of rebound hammer results is carried out based on the guide lines given in BS 6089: 1881 since IS 13311: Part II remains silent in this aspect.

as per rebound hammer test Ref. IS 13311 (part II) 1992 “Non Destructive testing of concrete –method of test, rebound hammer”. The maximum reading confirming M10 to M15 grade concrete.
