Retrofitting of RC Beams By Using Ferro Cement Jacketing

Abstract- Retrofitting refers to the addition of new members or components to older systems. In terms of civil engineering it refers to the strengthening of old structures. Many of the existing reinforced concrete structures do not meet the current design standards because of inadequate design and construction or need structural upgrading. They are in urgent need of repair, retrofitting or reconstruction because of fail or collapse due to various factors like corrosion, lack of detailing, failure of bonding between beam-column joints, increase in service loads, etc., leading to spalling, cracking, loss of strength, deflection, etc. Innovative techniques for repair have many advantages over conventional techniques.

This paper presents the behavior and strength of reinforced concrete beams and columns strengthened with Ferro cement jackets. A total 15 beams were prepared from that three specimens of beams and columns are control beams. Remaining twelve beams are distressed at 60% and 80% of the ultimate load and retrofitted with Ferro cement in no of layers single and double layer respectively. The load deflection characteris

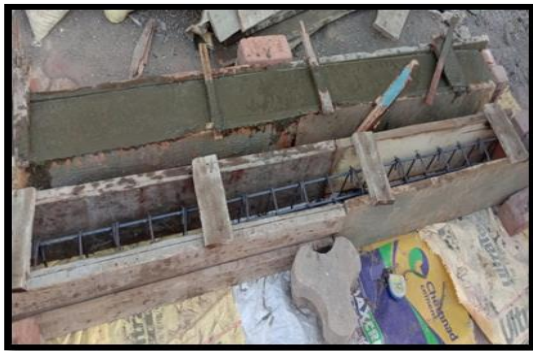
Figure 2.2 Casting of specimen

The moulds were prepared using plywood. The length of beam was 2200mm with cross section 150 mm x 230 mm. The design mix ratio of M20 was adopted for casting the beam. 21 under reinforced beams were cast, 3 as control specimens and 18 beams for retrofitting. 2 bars of 8 mm tor are provided as tension reinforcement at bottom, 2 anchor bars of 8mm tor at top of the beam as stirrups. All beams and control specimens were cast and wet cured for 28 days.

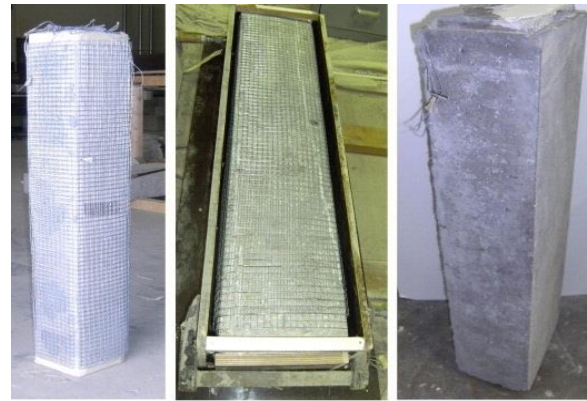
Figure 2.4 Process Of Retrofitting

After first stage of loading, the distressed beams were retrofitted by using ferrocement jacketing. Ferrocement is another form of reinforced concrete in which cement sand mortar is reinforced with closely spaced MS welded wire mesh. The surface of the distressed beam are roughened by using hacker and wire mesh was wound over it. The mesh was tightened using binding wires. A thick cement paste was applied as bonding agent before the application of mortar having the ratio of 1:3 by weight and water cement ratio was kept as 0.5. The 20 mm thickness of mortar was applied on the beam surface. The retrofitted beams were cured for 28 days in curing tank.

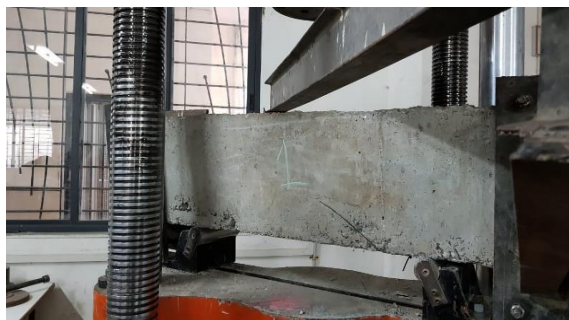
Figure 2.3 Pre- retrofitting loading

Except for the control beam C1, C2, C3 which are loaded monotonically, all other beams are preloaded up to 60% and 80% until the first cracked is not formed. During loading, the specimen is visually inspected and cracks are marked. The specimen is then unloaded and then retrofitting is carried out by welded wire mesh jacketing.
