Identifying Critical Safety Issues And Proposed Countermeasures on Nh965dd - A Case Study From Bhor To Mahad 47km

Two-Lane NH965DD (BhorToMahad 47km)

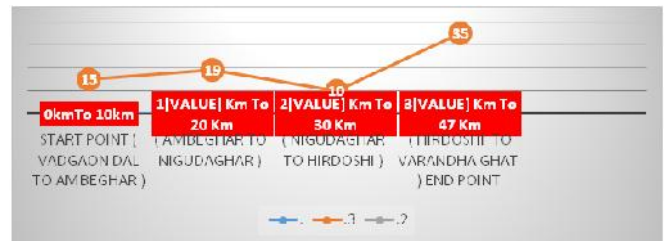
Chart:4 Potholes Data Based On Location

SR.NO	ACCIDENT LOCATION IN KM	LOCATION	NO. OF ACCIDENT IN LAST 5 YEAR
1	0 To 10	Start point (Vadgaon Dal To Ambeghar)	15
2	10 To 20	(Ambeghar To Nigudaghar)	19
3	20 To 30	(Nigudaghar To Hirdoshi)	10
4	30 to 47	(Hirdoshi To Varandhaghat) End point	35

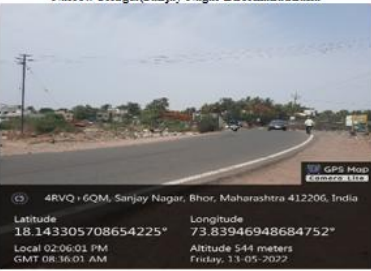
2	<p>Narrow bridge(Sanjay Nagar Bhornabadnaka)</p>

<p>GPS Map 4RVQ+6QM, Sanjay Nagar, Bhor, Maharashtra 412206, India Latitude 18.143305708654225° Longitude 73.83946948684752° Local 02:06:01 PM Altitude 544 meters GMT 08:36:01 AM Friday, 13-05-2022</p>	<ol style="list-style-type: none"> 1.Sudden reduction in lane width. 2.Presence of concrete parapet wall poses as a hazard. 3.Vehicles speeding / overtaking near narrow bridge. 4.Pro at night due to low visibility. 	<ol style="list-style-type: none"> 1.Warning signs should be provided before the approach of a narrow bridge. 2.The guard rail should be embedded in the parapet wall 3.The approach of the narrow bridge should be free from vegetation to provide a clear view of the bridge.
3	<p>Intersections (VenayadiBhor)</p>

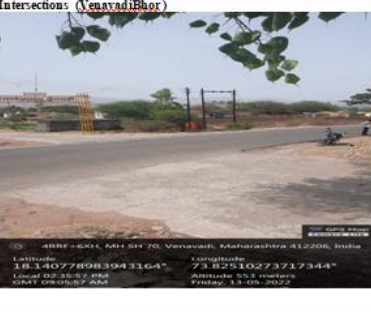
<p>GPS Map 4RR+6Q1, MH SH 70, Venayadi, Maharashtra 412206, India Latitude 18.1407780983943164° Longitude 73.82510273717344° Local 02:36:57 PM Altitude 513 meters GMT 08:06:57 AM Friday, 13-05-2022</p>	<ol style="list-style-type: none"> 1.Mostly unsignalised and uncontrolled 2.Many are located under the influence area of the curve 3.Restricted sight distance from minor roads 4.Over Speeding 5.Undisciplined driving 	<ol style="list-style-type: none"> 1.Delineation and warning signs should be provided 2.Channelize vehicular movements wherever possible 3.Restrict speed on the minor road before merging by speed humps 4.Corners should be flared for better turning movement 5.Road marking and signs to be provided

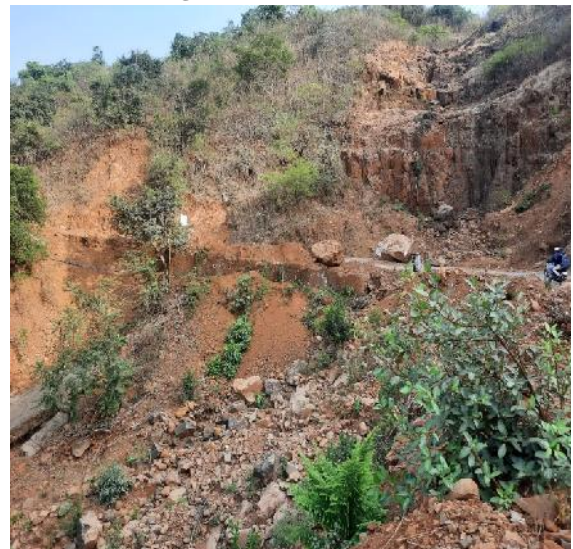
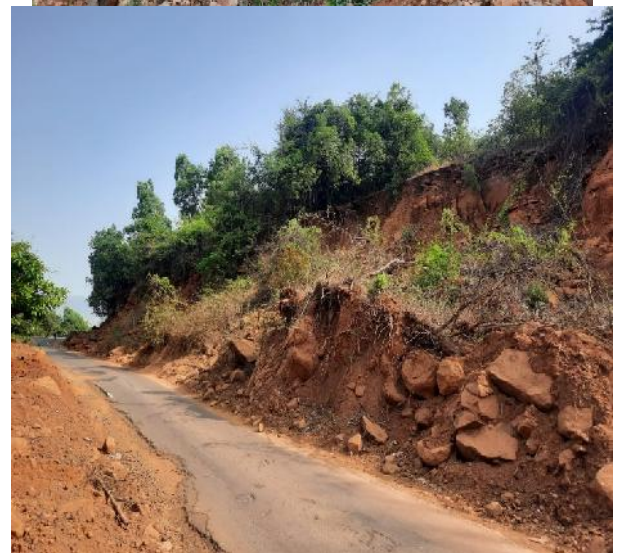
Fig 1 Land slide (VardhaghatBhor)

4. Problems due to slope failure

Excess precipitation leads to intense surface-water flow with pressure and triggers mudslides. Consequently

- Erosion and mobilisation of loose soil or rock on steep slopes.
- Removal of material from the toe of the slope.
- Saturation by rainwater reducing shear (moving apart) resistance of the slope material.

Moreover, increased seepage of water into ground through soil or cracks in the bedrock that results in,

- Groundwater concentration in the bedrock and pressure on rocks making it to fall.
- Increase in pore pressure affecting the soil grains
- Cracks in bedrock, developed by the impact of gravity or groundwater
- Freeze and thaw weathering in extreme weather conditions.

- Deforestation
- No check over weak material (loose sand/rocks/debris)
- Improper drainage
- Silting of rivers due to improper disposal of muck and other construction materials.

1. **Benching:** Horizontal benches can be excavated into a slope for most effective protection from steep slope failures as it reduces the height of slope.
2. **Creating Support for Overhang:** Overhang of rocks should be scaled or a wall, creating support for it should be built with suitable strong material else sandbags can be used.
3. **Retaining Wall :**Retaining wall gives support to slope material by restraining the lateral movement of the material. Soil parameters like bearing capacity, influence the design of retaining wall.
4. **Constructed Gabion wall**
5. **Rock bolts**
